Track substructure renewal on Polish State Railways

Dipl.-Ing. Henryk Beczkowski
Head of Department for
Mechanisation (retired)
Polish State Railways (PKP)

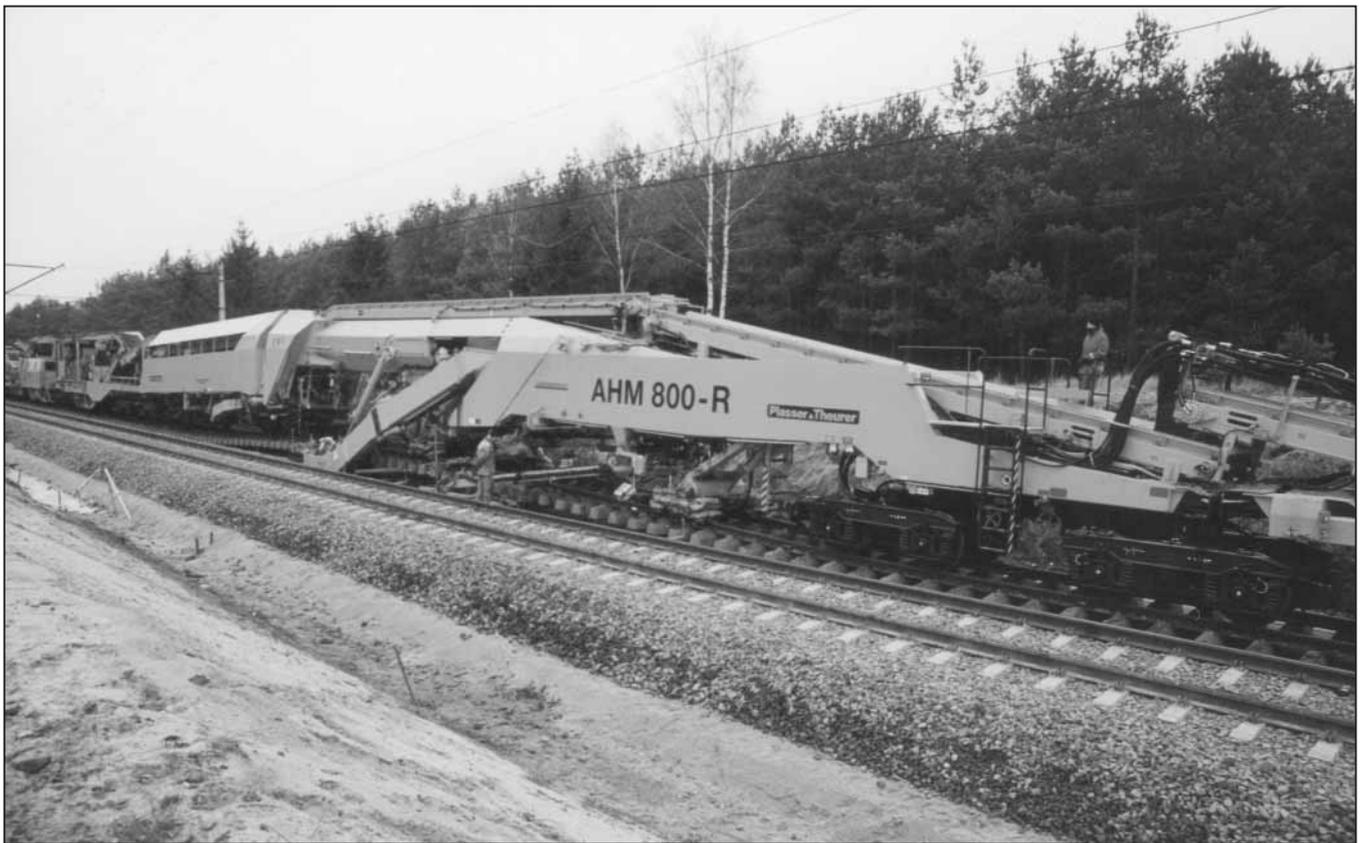
Fig. 1: AHM 800-R formation rehabilitation machine

The analyses yielded that the method deployed by the AHM 800-R would meet the requirements of PKP with respect to substructure improvement work. Thus, a machine of this type was procured (Fig. 1).

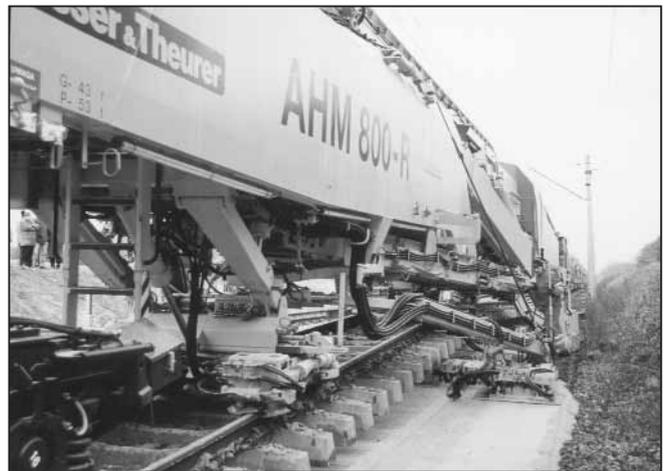
Fig. 2: Raising the track and insertion of the new formation protective layer without dismantling of the track skeleton, using the AHM 800-R

- the work is performed without dismantling of the track skeleton (Fig. 2), as opposed to the traditional method used on PKP for substructure work or the insertion of a formation protective layer which, making use of construction machines, required the complete removal of the track;

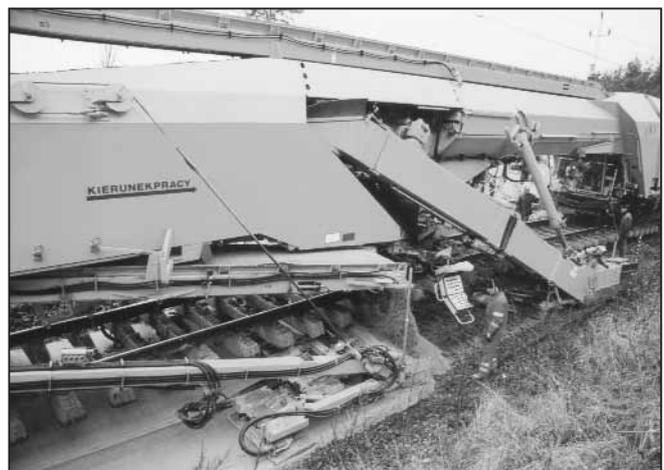
Fig. 3: Excavation of material and simultaneous installation of a compacted formation protective layer

- during operation, the machine does not exceed the clearance gauge;
- the machine enables the formation protective layer to be installed simultaneously to the removal of spoil in the upper substructure layer (Fig. 3);
